DEPARTMENT OF TRANSPORTATION

Quality Assurance and Source Inspection

Contract #: 04-0120F4Cty: SF/ALA Rte: 80 PM: 13.2/13.9File #: 69.28**WELDING INSPECTION REPORT****Resident Engineer:**Siegenthaler, Peter**Address:** 333 Burma Road**City:** Oakland, CA 94607**Report No:** WIR-018913**Date Inspected:** 22-Dec-2010**Project Name:** SAS Superstructure**OSM Arrival Time:** 700**Prime Contractor:** American Bridge/Fluor Enterprises, a JV**OSM Departure Time:** 1900**Contractor:** Zhenhua Port Machinery Company, Ltd (ZPMC), Changxing Island **Location:** Shanghai, China**CWI Name:** Li Yang**CWI Present:** Yes No**Inspected CWI report:** Yes No N/A**Rod Oven in Use:** Yes No N/A**Electrode to specification:** Yes No N/A**Weld Procedures Followed:** Yes No N/A**Qualified Welders:** Yes No N/A**Verified Joint Fit-up:** Yes No N/A**Approved Drawings:** Yes No N/A**Approved WPS:** Yes No N/A**Delayed / Cancelled:** Yes No N/A**Bridge No:** 34-0006**Component:** OBG Segment**Summary of Items Observed:**

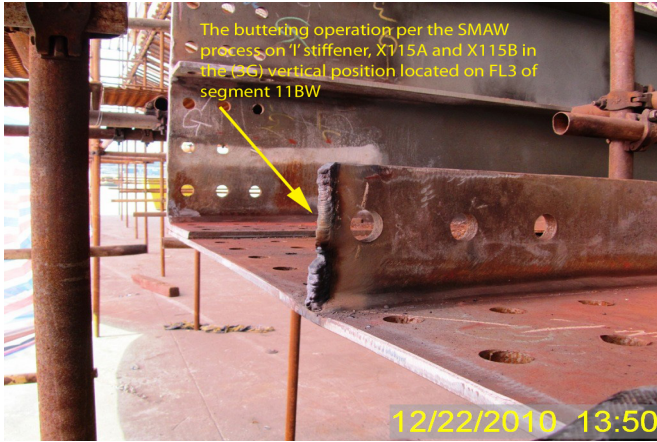
The QA Inspector observed the buttering operation per the SMAW process on 'I' stiffener, X115A and X115B in the (3G) vertical position located on FL3 of segment 11BW. The welder ID was 040738. The ZPMC CWI was identified as Li Yang. The welding was performed against welding repair report B-WR17898. The welding variables recorded by QC appeared to comply with the WPS-345-SMAW-3G (3F)-Repair.

The QA Inspector observed the buttering operation per the SMAW process on 'I' stiffener, X115A and X115B in the (3G) vertical position located on FL3 of segment 11BW. The welder ID was 046709. The ZPMC CWI was identified as Li Yang. The welding was performed against welding repair report B-WR17898. The welding variables recorded by QC appeared to comply with the WPS-345-SMAW-3G (3F)-Repair.
